MACON LAKE DAM
MACON COUNTY, MO.
MO 10153

PHASE 1 INSPECTION REPORT NATIONAL DAM SAFETY PROGRAM

PREPARED BY: U.S. ARMY ENGINEER DISTRICT, ST. LOUIS

OCTOBER, 1980

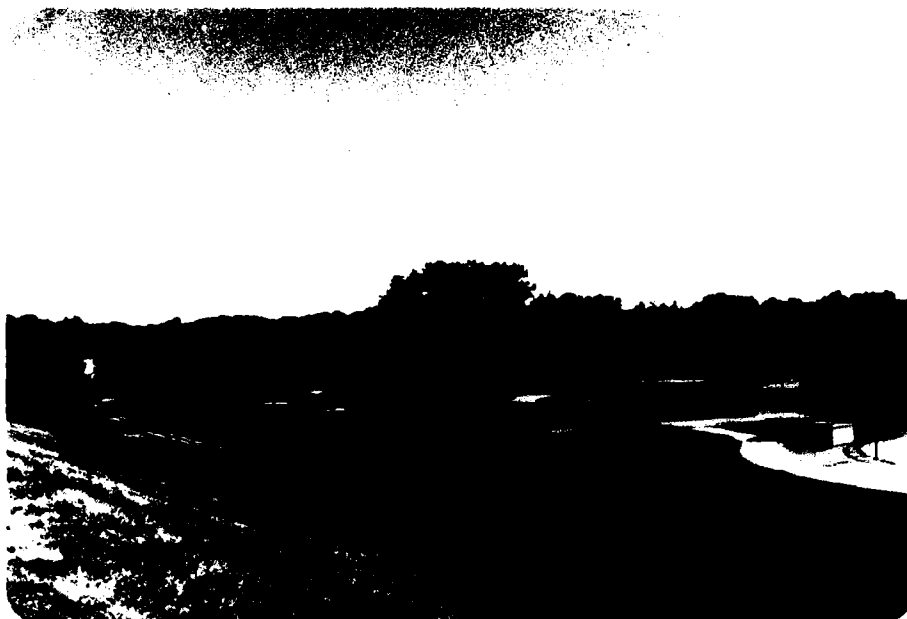
PHOTO NO. 10 - LOOKING DOWNSTREAM FROM STATION 7+00

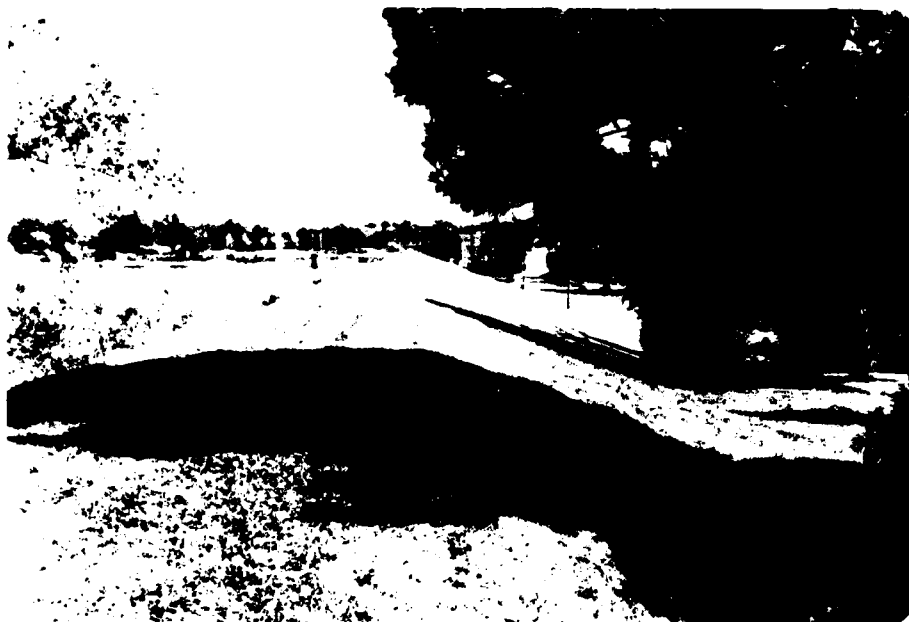
- (4) Downstream Slope. The downstream slope is very well vegetated with adapted grasses. No cracks, deformations, rodent activities or seeps were observed on the slope or along the toe of the slope. Photos 5 and 12 show the downstream slope. The ornamental trees in the right abutment trough, shown in Photo 12, should not endanger the embankment. Mr. Jensen reported that a seep area appears intermittently about 70 feet downstream from the toe of the dam near Station 8+00. This seep has been observed ever since the dam was built and would appear to be located in the old natural drainageway. The seep area was dry to a depth of 2 feet below the surface at the time of inspection. Photo 28 shows the seepage area.

PHOTO NO. 12 - CREST AND DOWNSTREAM SLOPE FROM RIGHT END

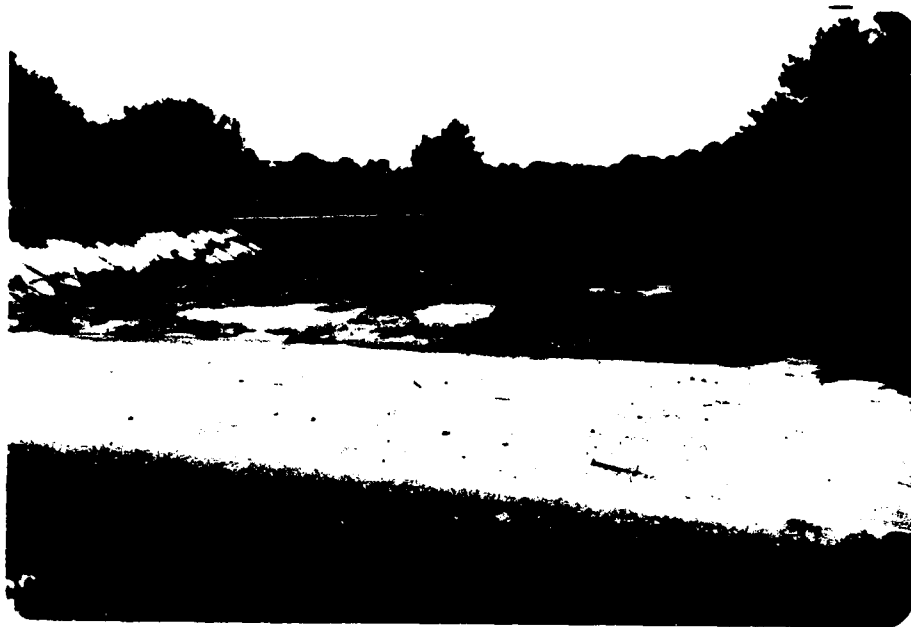
The floor and side walls of the first (original) exit channel section are quite badly cracked and checked. Some cracks up to 3/4-inch in width and some holes in the floor up to 12-inches in diameter with eroded channels under the floor extending 4 to 5 feet or more were observed. Photos 14 and 16 show the first section of the exit channel with vegetation (mostly weeds) growing in the cracks. Photos 15, 17, 18, 19 and 20 show cracks and holes in the floor and side walls of the first section of the channel.

PHOTO NO. 14 - LOOKING DOWNSTREAM IN SPILLWAY EXIT CHANNEL
FROM CREST

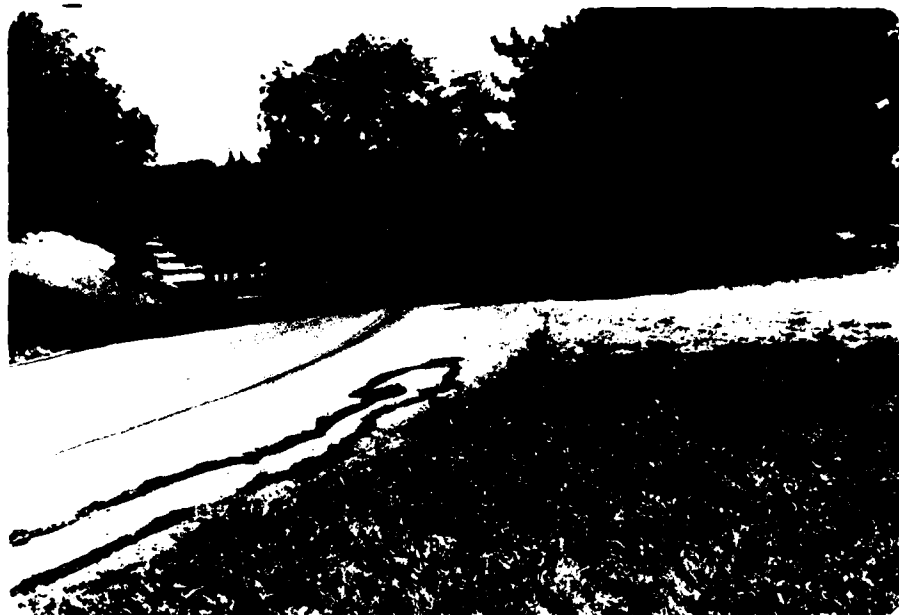
PHOTO NO. 30 - LOOKING DOWN THE ROADWAY AT LEFT END
OF DAM

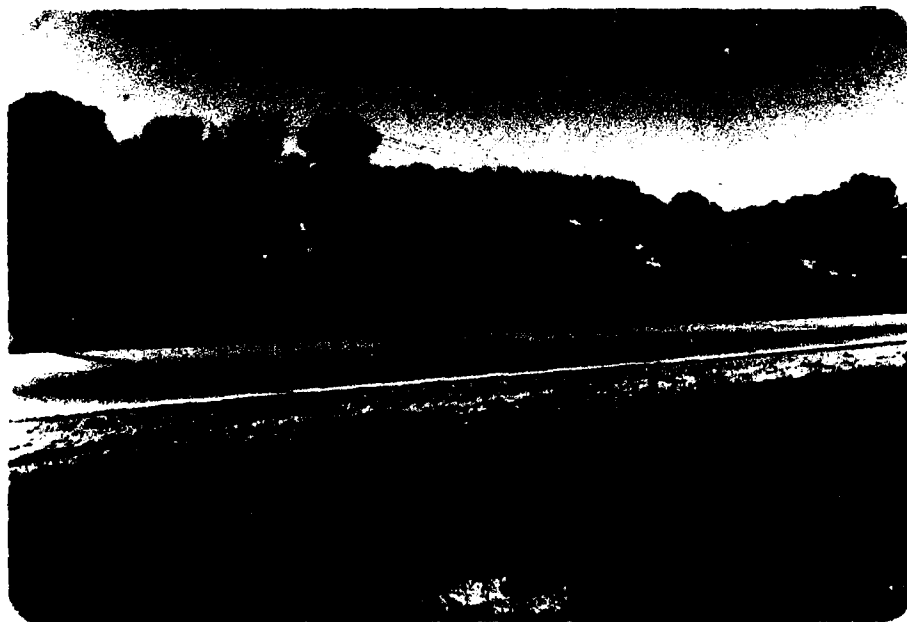
PHOTO NO. 33 - DOWNSTREAM HAZARD FOUR (4) HOUSES JUST EAST
OF THE WATER PLANT

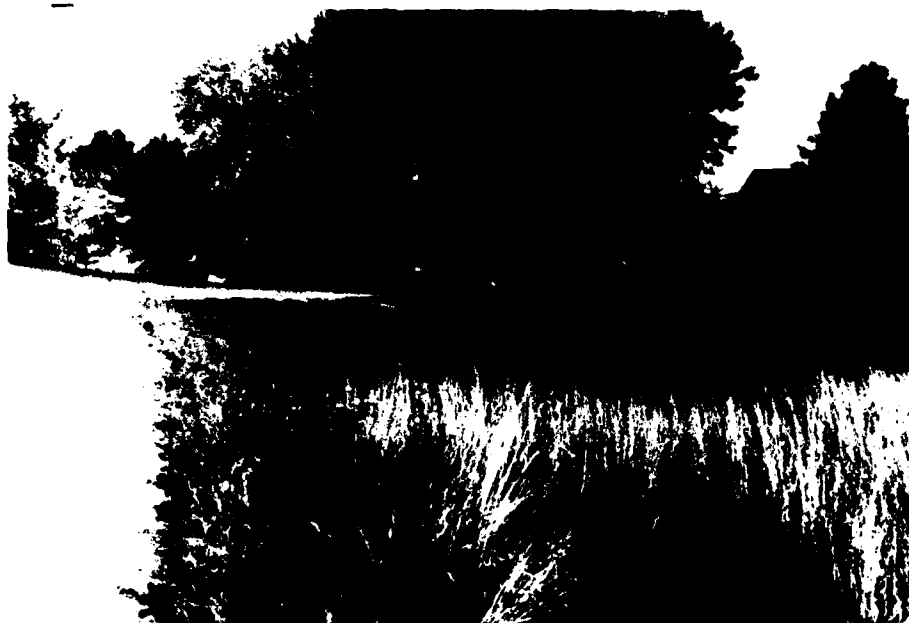
PHOTO NO. 34 - DOWNSTREAM HAZARD, JUST SOUTH OF HIGHWAY
AND ON RIGHT BANK

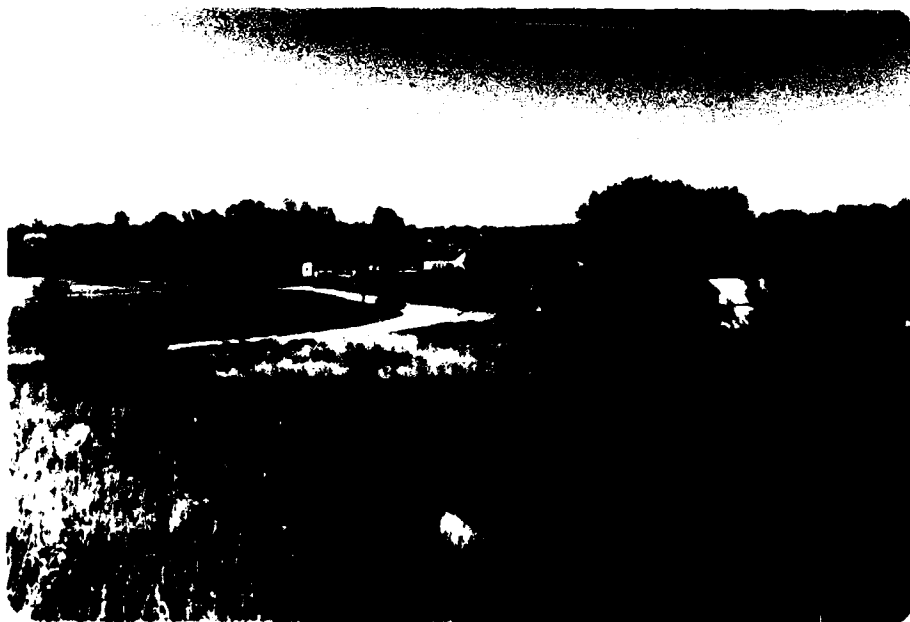
PHOTO NO. 35 - ANOTHER VIEW OF HOUSE JUST SOUTH OF HIGHWAY
AND ON RIGHT BANK
